EMD Test Data Documents

Note: The following documents represent examples of numerous QMI product performance tests accumulated worldwide since 1986.

Sequence IIIE Test

Re: QMI Engine Treatment / Sequence IIIE test shows 88% wear reduction

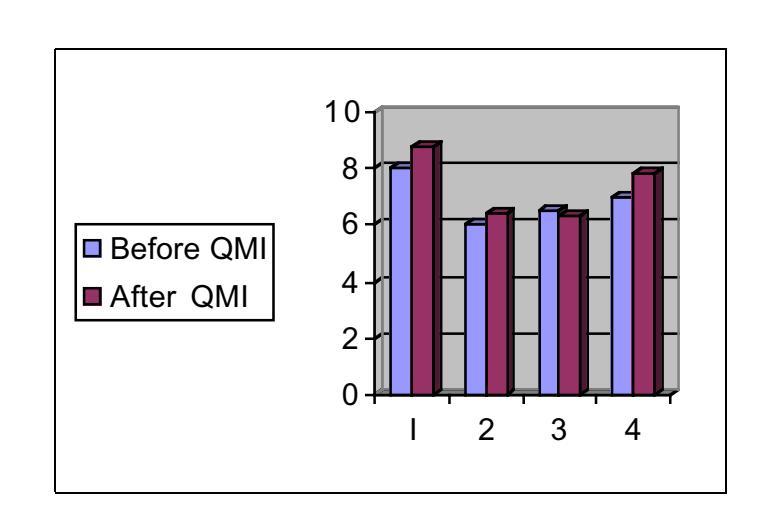
Bus Fuel Mileage – Before and After QMI Applications

The following represent fuel MPG (miles per gallon) figures recorded on four diesel powered school busses, before and after QMI applications:

Bus	Before QMI	After QMI
Ι	8.00	8.80
2	6.00	6.46
3	6.50	6.30
4	7.00	7.85

Before QMI	6.88
After QMI	7.35

Fuel MPG Increase: 6.8%
